Development of a Road Safety Engineering Modelling Tool

Samuel G. Charlton, Ph.D.

25 July 2003

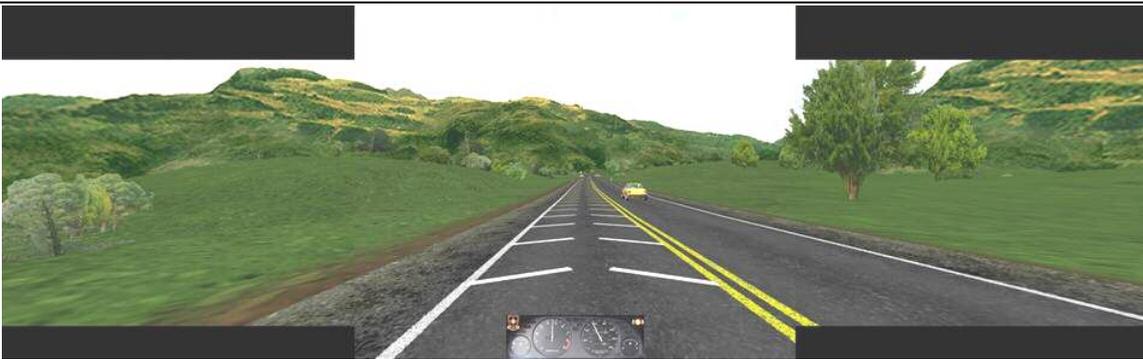
Figure 1. An example of the 130° field of view from the driving simulator apparatus.

The primary experimental apparatus was the driving simulator described for the previous research phase. Participants drove the simulated road using the steering wheel and foot pedal controls. The vehicle dynamics of the simulated vehicle represented a passenger car with a 2 litre engine and an automatic transmission. The simulated road surface was high friction corresponding to dry asphalt and scene visibility corresponded to clear daytime conditions. Three driving scenarios were created: an "as-is" or standard representation of the 25 km study road; a scenario with perceptual countermeasures added; a scenario with explicit (attentional) speed restrictions added. Each of these three scenarios contained representative traffic densities (approximately 14,000 vehicles per day) modelled using information from traffic counts and video recordings of the study road. In addition, a 7 km practice scenario with reduced traffic levels was created from a short section of the "as-is" scenario to allow the participants to familiarise themselves with the simulator.
